# Appendix 2 Leakage and Pressure Management

November 2022

## Park Lake Drought Permit Application 2022

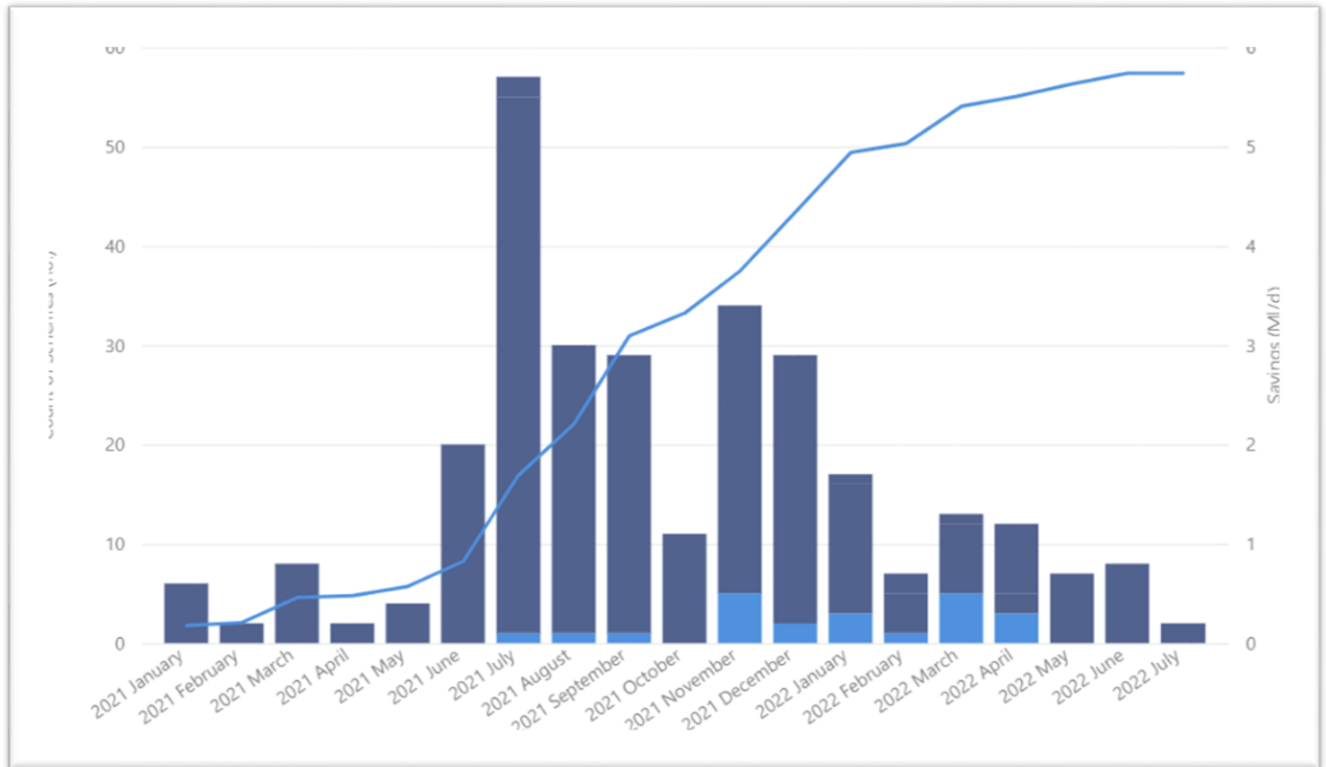
**Figure 3 - Total leakage reduction**

See Figure 3 below showing the relationship between new pressure valves installed and total leakage reduction.

*Blue cumulative Trend line – Total leakage reduction*

*Light blue bars - New Pressure Valve digital Controllers*

*Dark blue bars – new pressure valves installed*

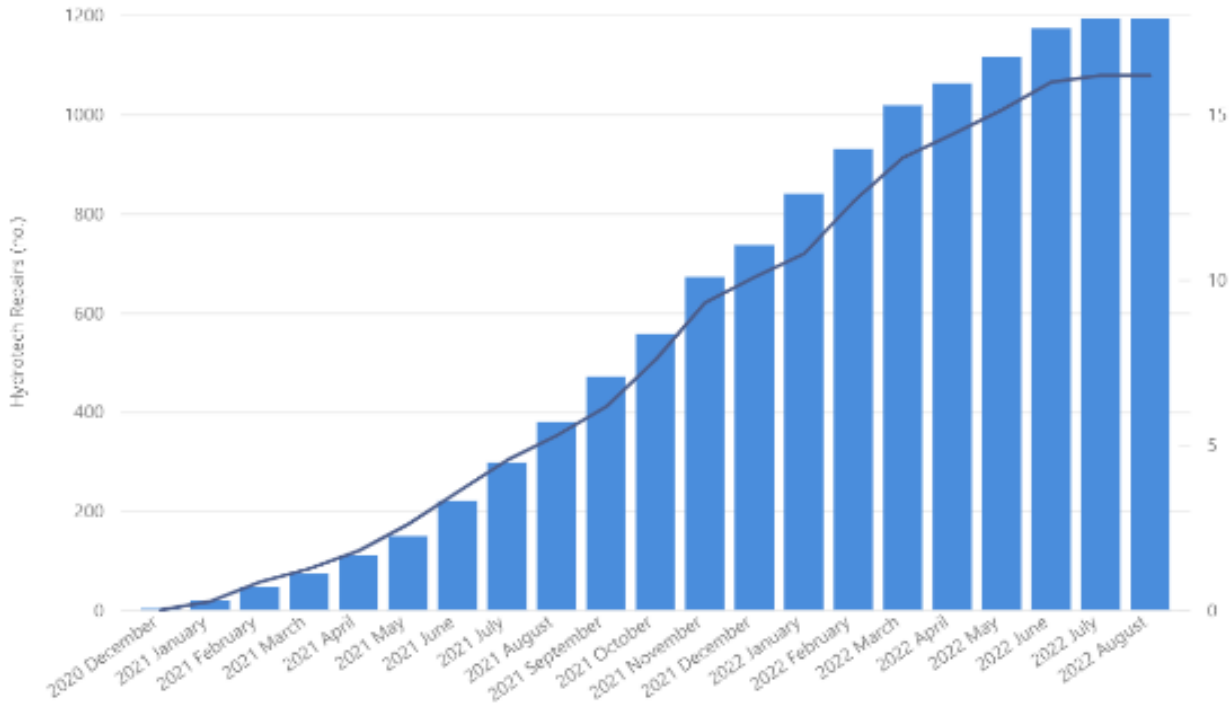
Figure 4 - Graph showing total leakage saved against leakage repairs

Figure 4 below represents the total leakage saved (trend) and interventions (customer leak repairs and pipe renewals) required to achieve the leakage reduction.

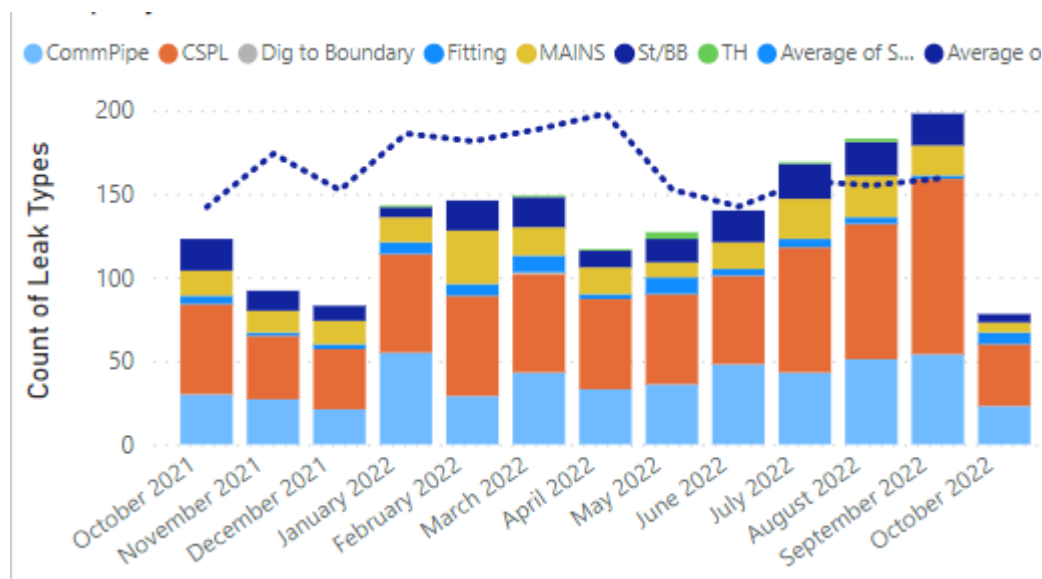
**Figure 5 – Detected Leaks in Operational Areas Colliford WRZ (Area 2).**

No fewer than 36 field technicians have been working in operational areas 1 and 2 since June 2022, the normal number, pre DI recovery and drought being c.15FTE. The additional field force has led to significantly increased numbers of found leaks. The average of the detected leaks in the rolling prior 12 months significantly uplifted since drought activities commenced.

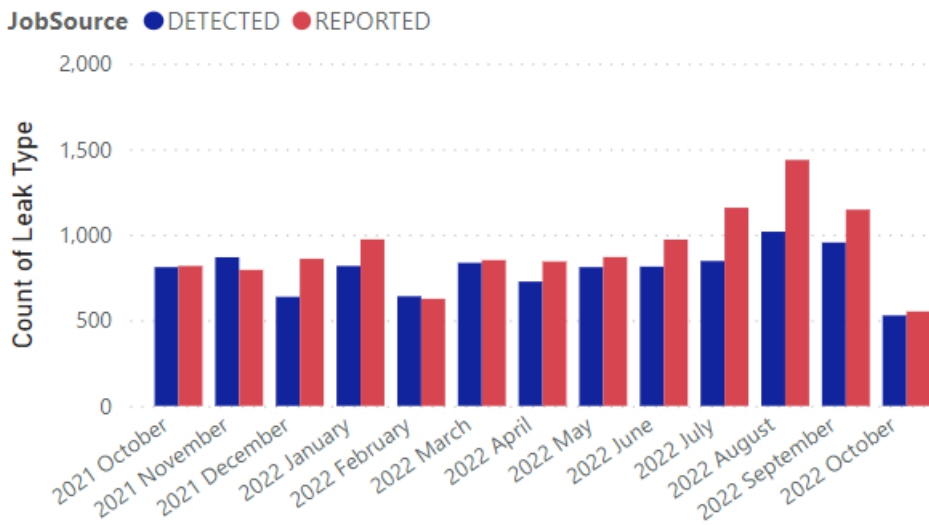
**Figure 6 – Detected Leaks compared to Customer Reported Leaks in Colliford WRZ**

Figure 6 below shows the number of detected leaks compared to customer reported leaks in the Colliford WRZ. Detected leaks are found due to their typical invisibility and the reported leaks are reported to us due to their visibility. Reported leakage is often responded to more quickly due to service affects (low pressure/No water/flooding), with detected leakage requiring additional effort to locate the leak e.g. with acoustics or listening equipment.

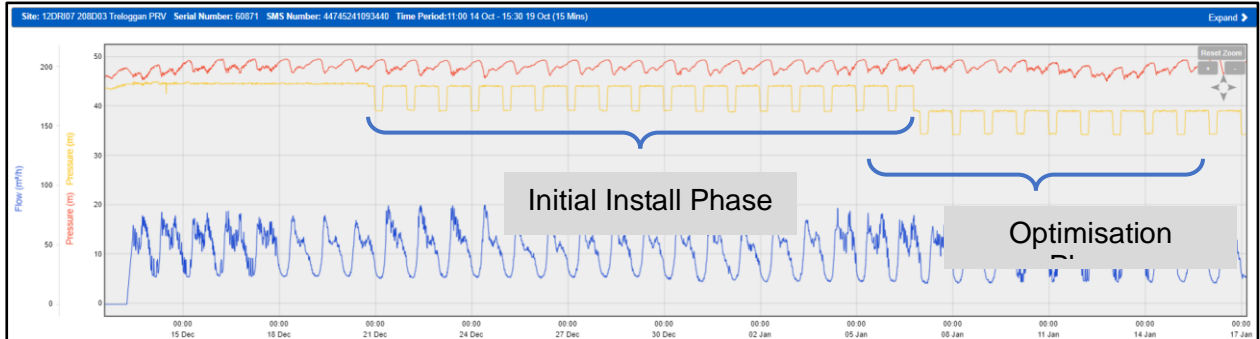
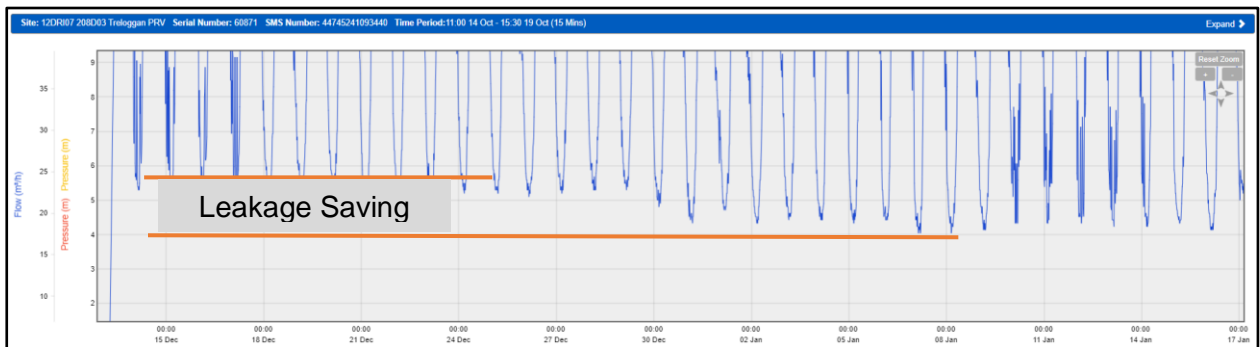
Below is an illustration of the demand reduction benefit achieved for one typical pressure management scheme if Colliford. The demand reduction was achieved wholly from

pressure management, the indicated drops in flow are not linked any leak repairs, purely from pressure reduction into the DMA>
